LANDSLIDES NEAR PEORIA*

GEORGE E. EKBLAW

State Geological Survey, Urbana

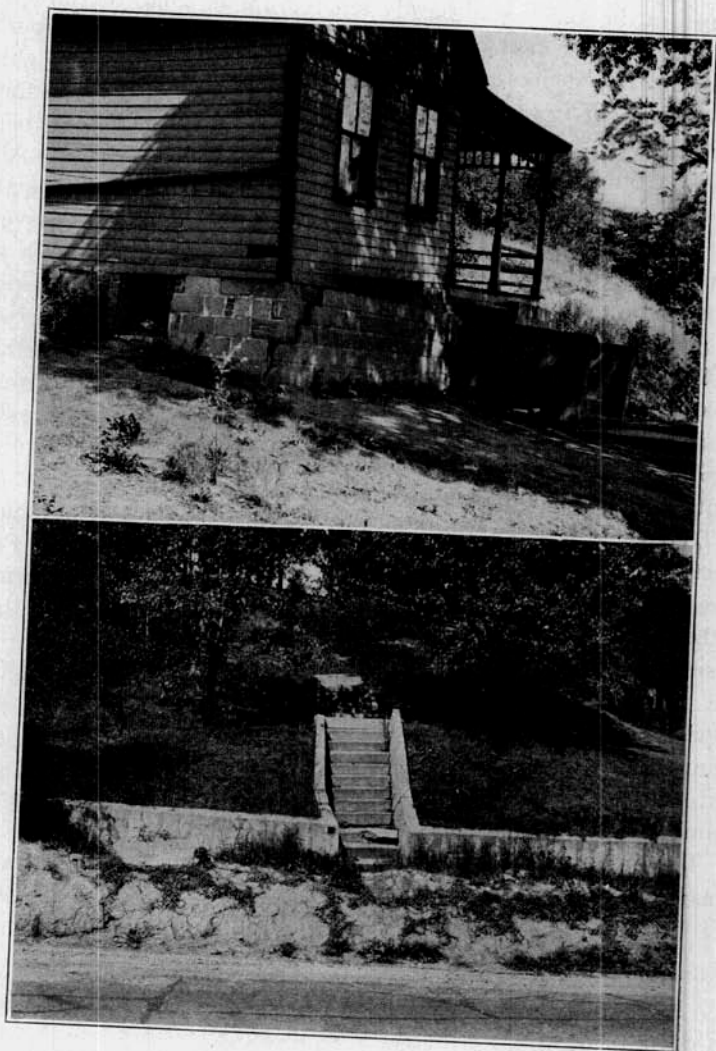
FIG. 1. (*Above*) Foundation of a house disjointed and displaced as a result of landslide movement. Note the tilted steps and handrail and the distance the foundation has settled away from the porch at the right-hand corner.

FIG. 2. (*Below*) Steps broken and dislocated by landslide movement. The house that formerly stood here had to be moved away on account of the same landslide movement. Note also cracks in the wall and in the pavement in the foreground.

The conditions described at this locality north of Sparland are almost duplicated at Bartonville, a few miles southwest of Peoria. There are practically no outcrops by which the strata can be determined, but there are two major horizons along which seepage and marshy depressions occur, and these are believed to be the same as those at Sparland. Everywhere the slope exhibits "eye-brow" landslips and the irregular alternation of arcuate ridges and crescentic depressions typical of landslide topography. Houses and other buildings on the slope have tilted and their foundations, the sidewalks, the pavement, and the retaining walls have been disrupted by the landslide movement (Fig. 2).

The only real cure for these slides is drainage. However, it would be necessary to lay drains along each potential horizon of seepage and at the exact line and carry the water down the slope wherever there was a dip in the contact. The depressions would also have to be drained, and surface water would also have to be drained away. A system of drains sufficient for these purposes and the labor in determining the precise location for them as well as in laying them in talus material would be so expensive that the cost of drainage seems prohibitive. The most practical advice is to avoid such locations when considering construction of any kind.
