## CAUSE AND PREVENTION OF POTENTIAL ROCK-FALLS NORTH OF SAVANNA, ILLINOIS\*

GEORGE E. EKBLAW

*Illinois State Geological Survey, Urbana.*

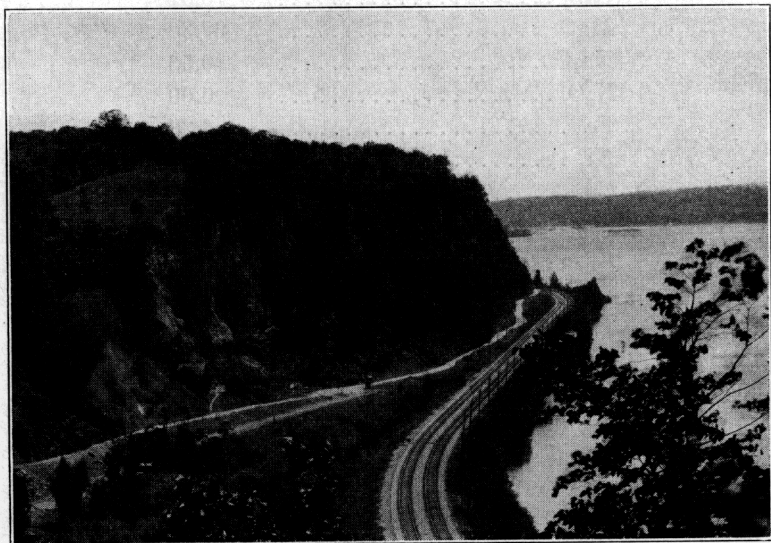
An unusually interesting problem in engineering geology is involved in a situation that occurs two miles north of Savanna, in the northwest part of Illinois. At this locality Mississippi River flows almost against the east wall of its valley (fig. 1). The valley-wall itself is a precipitous bluff approximately 250 feet high. A

FIG. 1. View of bluff two miles north of Savanna, showing relations of the river, the railroad, and the highway. (Photo by Illinois State Highway Division.)

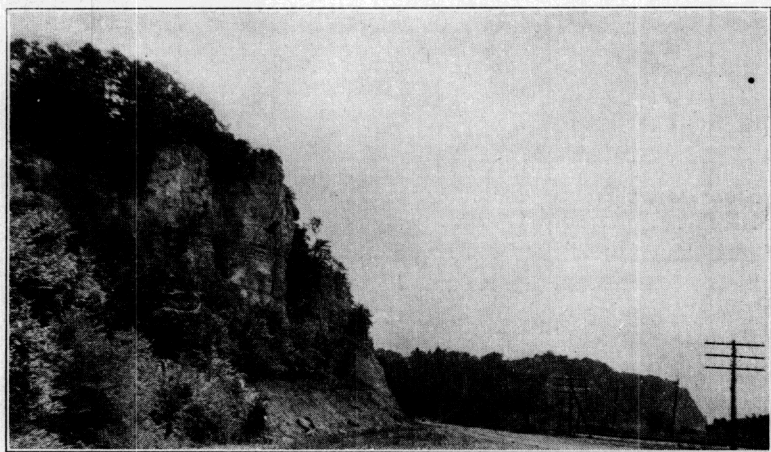
At the precise locality under discussion (fig. 2) the highway originally lay between the railroad and the river, but some years ago the railroad company realigned its roadway and prepared a new public road between the railroad and a projecting nose of the bluff. In order to make room for the new public road it was

necessary to remove the toe of the talus slope at the foot of the bluff. This caused the talus to slide down from time to time, so that for about two years the railroad company had a steam shovel on hand to keep the road clear. A wider roadway with more clearance at this place was desired for the new concrete highway (State Highway No. 80) that is being constructed along the river, so the rest of the talus slope was removed (fig. 2) and was dumped into the river on the west side of the railroad. Preparations were made to blast down an intermediate shelf of rock along the south part of the nose.

FIG. 2. Near view of bluff two miles north of Savanna, where conditions favor rock-falls. (Photo by O. F. Goeke.)

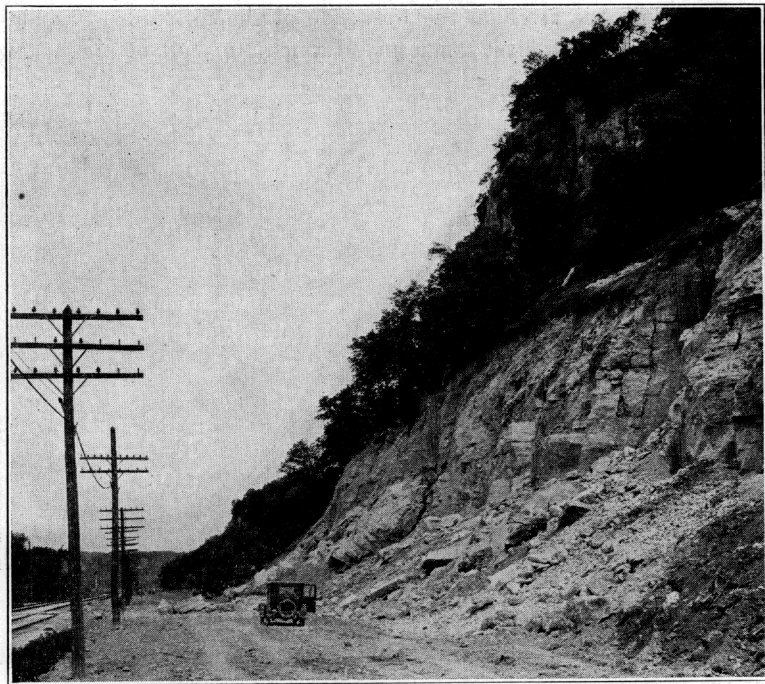
While this work was in progress, some small rock-falls occurred at the north part of the nose, where the talus had been completely removed (fig. 3). These falls alarmed the resident highway engineer, who informed the district engineer, who in turn appealed to the Illinois State Geological Survey for advice. Accordingly an examination was made, about a year ago.

FIG. 3. Close view of the same bluff, showing rock exposed by clearing away talus and also showing small rock-falls. (Photo by Illinois State Highway Division.)

In view of these conditions it was recommended that such small falls as had already occurred should not be removed, but that they should be supplemented by other masses of rock, either blasted from the face or recovered from the dump. These masses would serve as an artificial talus (fig. 3) that would prevent the shale from yielding laterally and thus would prevent rockfalls. The insertion of well-points along the contact between the shale and limestone in order to drain away the seepage before it emerged and the sealing of the surface sink-holes were also considered, but they were not deemed to be feasible or wholly effective schemes.

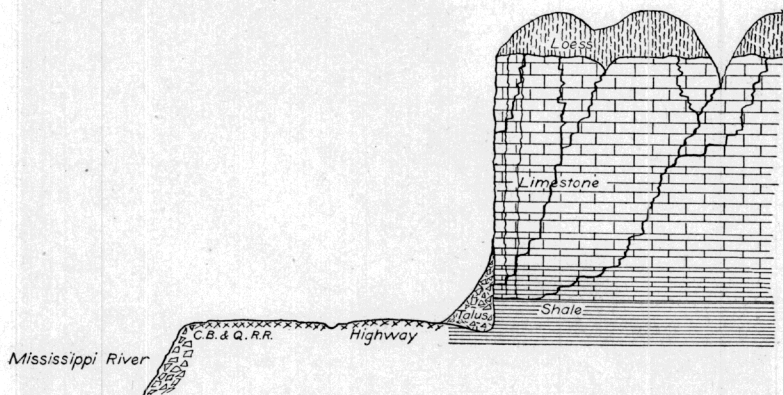
This examination revealed that most of the rock exposed in the bluff consists of Silurian limestone and dolomite (fig. 4), of which the upper part belongs in the Niagaran series and the lower 30-40 feet belongs in the Alexandrian series. About 10 feet of Maquoketa (Ordovician) shale was exposed beneath the limestone at the base of the bluff where the talus had been removed. Seeps and springs occur at and just above the contact between the shale and limestone. The limestone is covered by a mantle of loess as

much as 40 feet thick, approximately. Sinkholes occur on top of the bluff and extend through the loess into the limestone.

The rainfall that is precipitated on the top of the bluff soaks down through the loess and gathers in the sinkholes, whence it continues its way downward through solution channels and crevices in the limestone until it encounters the relatively impervious shale.

Thence it moves laterally along the top of the shale to issue as seeps or springs wherever the contact between the shale and the limestone may be exposed. This water tends to soften the shale and to lubricate its contact with the limestone. When the shale is softened it tends to yield under the weight of the overlying rock. The removal of the talus allows the shale to squeeze outward, which in turn allows a mass of the limestone along the face to settle, to break loose, and to fall towards the road. In small rock-falls (fig. 5) there would be a rotatory movement outward at the base and downward along the fracture plane, but in large falls the top of the

rock would gain momentum more rapidly than the base and would topple outward soon after the movement started.

FIG. 4. Diagrammatic cross-section sketch showing geological conditions at highway cut two miles north of Savanna.

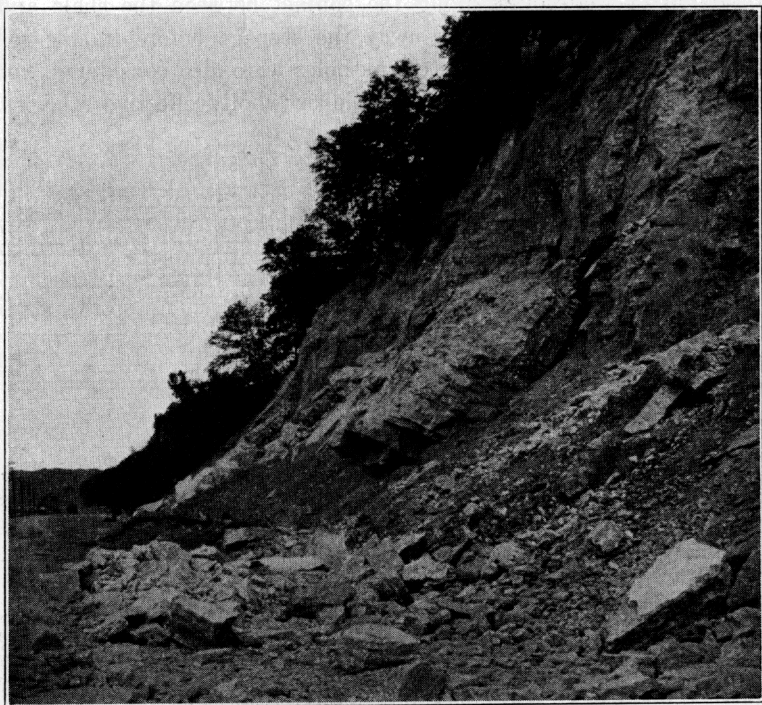
FIG. 5. Close view of small rock-falls and talus at foot of bluff. (Photo by Illinois State Highway Division.)
